# Recent Work on the Land Walls of Istanbul: Tower 2 to Tower 5

METIN AHUNBAY AND ZEYNEP AHUNBAY

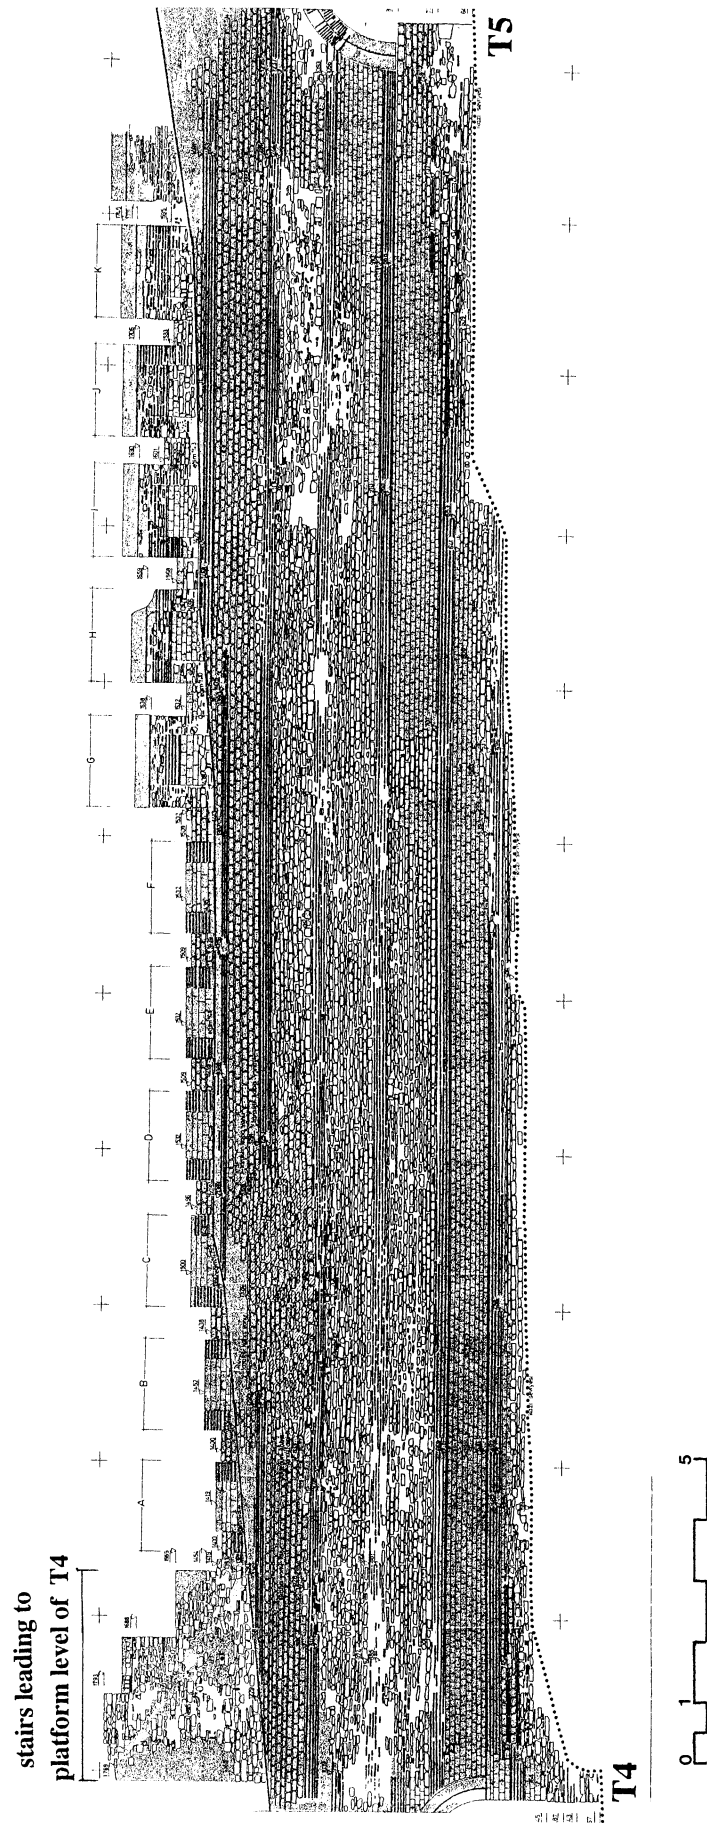
29 Istanbul, restoration project for the eastern facade of the curtain between Tower 4 and Tower 5 (implemented in 1993)

Between Towers 4 and 5 the western elevation of the wall was relatively well preserved, except for the upper part, which had been disturbed by the growth of trees. The fifth-century fabric could be followed up to the top of the wall. The eastern elevation, however, had been seriously damaged. Near the rampart level, areas repaired in the later Byzantine period had been detached from the wall. Sections about to collapse were carefully surveyed, and their individual stones and bricks numbered. Then they were dismantled and reassembled, using the original material.

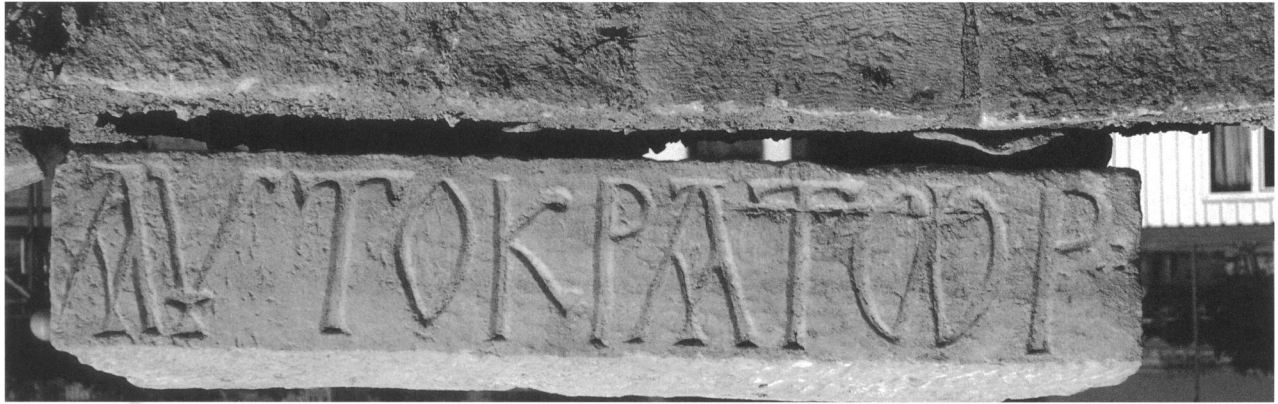
30 Istanbul, block inscribed with AUTOKPATOP, found between Tower 4 and Tower 5, 1993

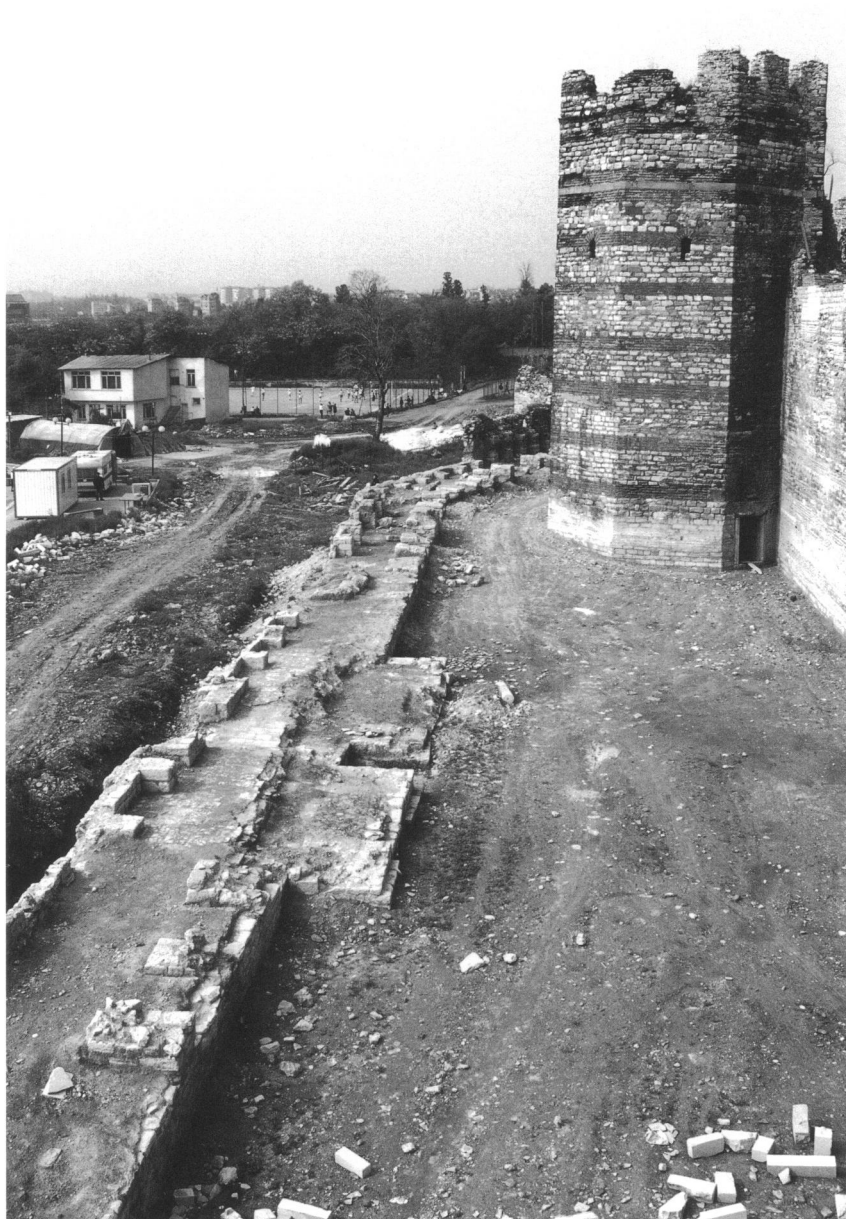
31 Istanbul, outer wall and Tower 4, with the remains of stairs leading to Tower 3a, 1993

The outer wall becomes visible above ground starting at a point in front of T3 in the main wall. Tower 3a in the outer wall does not exist today, but it must have stood until the 1940s, since it is marked on Jacques Pervititch's map from 1939 (Fig. 1). By examining the outer wall closely and taking measurements it was possible to detect traces where the lateral walls of T3a bonded with the outer wall. Excavation was conducted to find the foundations of T3a, but this attempt was in vain because at a depth of about 1.5 meters the reinforced concrete foundations of the former tanneries were encountered.

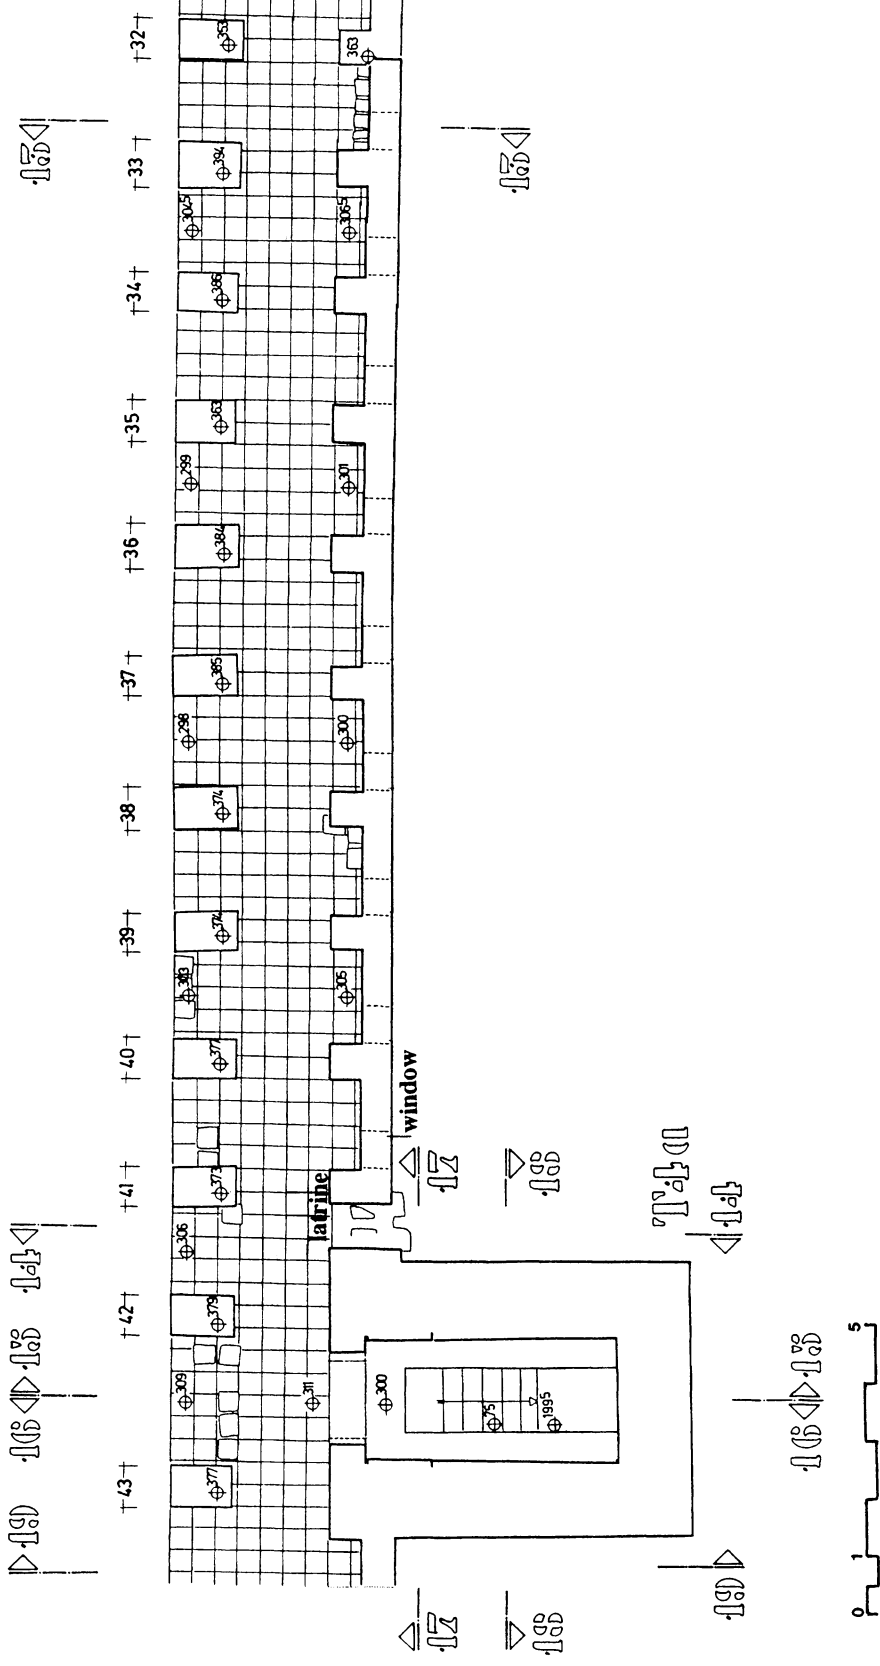
32 Istanbul, detail from the restoration project for the outer wall between Tower 3a and Tower 4a

The walk level of the outer wall has a closed battlement and is roofed by a vault (Fig. 32). The lowest part of the screen wall consists of dressed sandstone blocks, surmounted by brick masonry with embrasures, which were at a later date converted to loopholes. The screen is buttressed by wall piers, set 1.50 meters apart. Corresponding to the but-

tresses are free piers along the rear edge of the walk. A second level of defense was supported by these vaults. The plan, taken at the base of the screen, below the brick masonry, shows the construction to be similar to the older parapet of the main wall not only in design but in some dimensions as well.

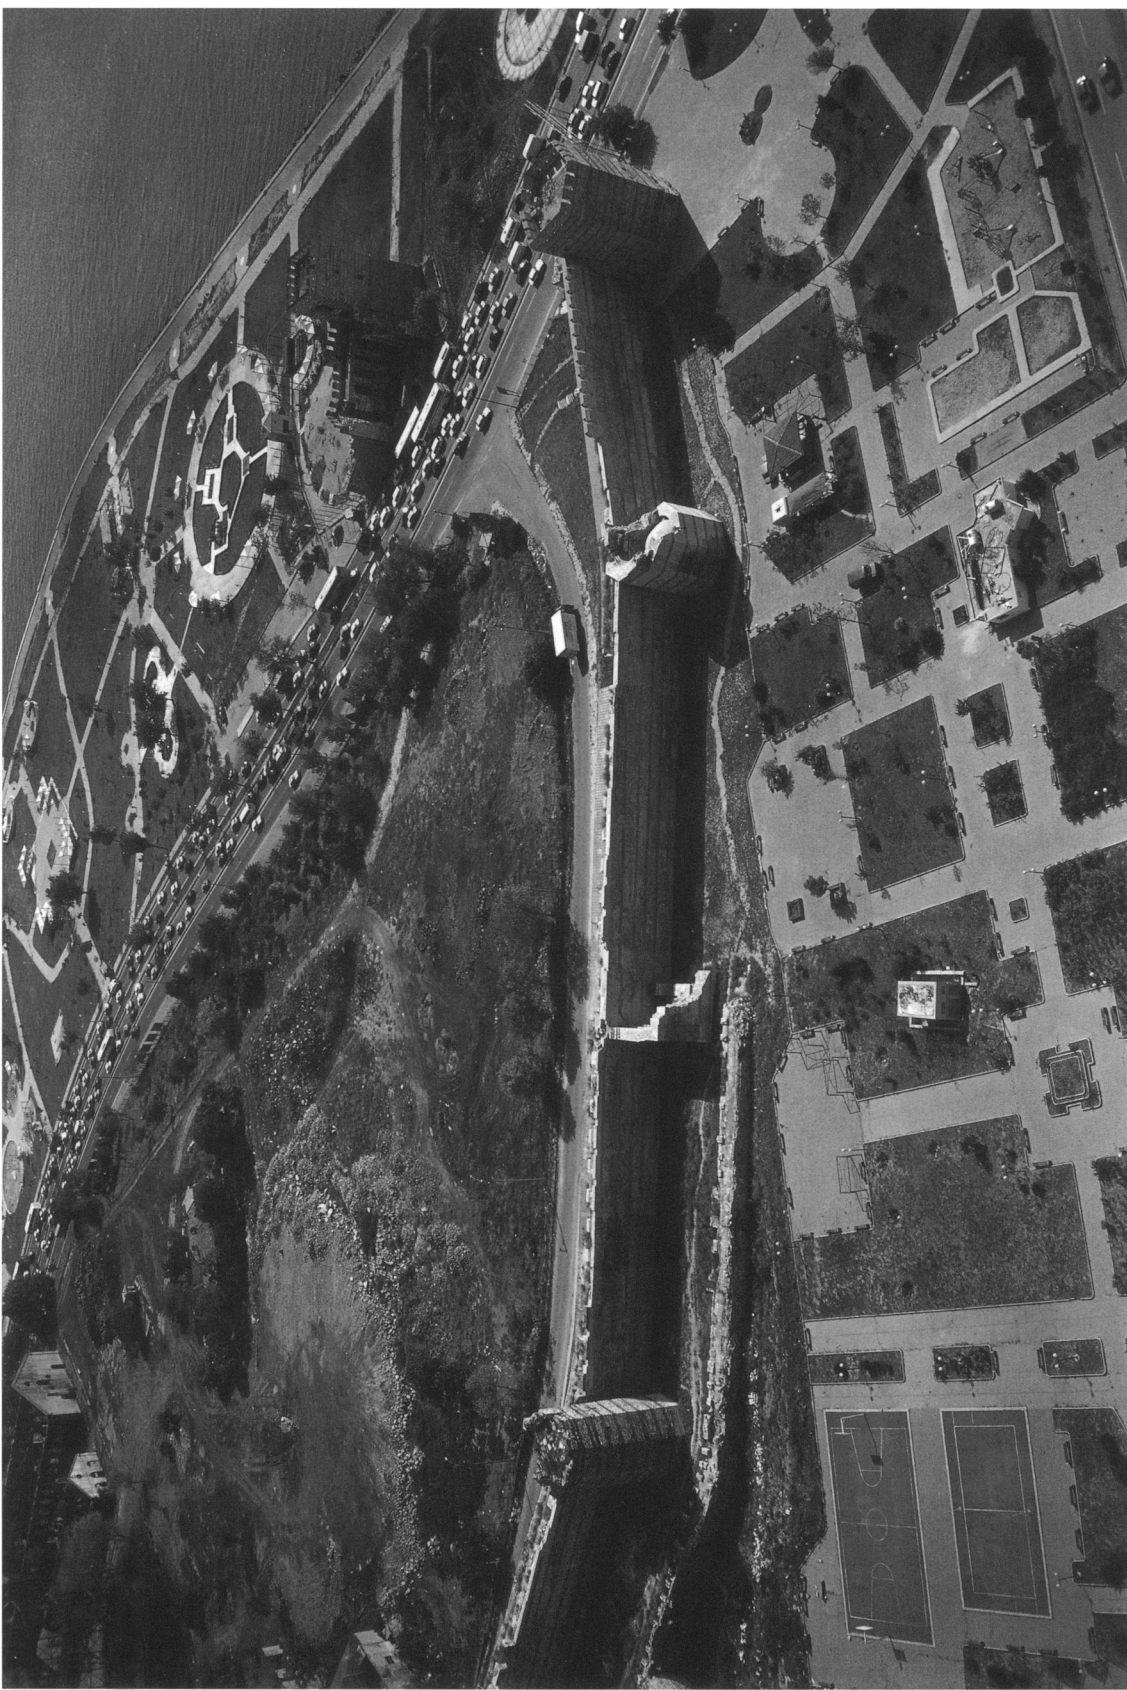
33 Istanbul, general view of Tower 1 to Tower 4, after restoration (photo: A. Neftçi, 1994)
